# NMPSIA

## Espanola Public Schools

*Espanola Valley High School*

### *Loss Control & Safety Audit*

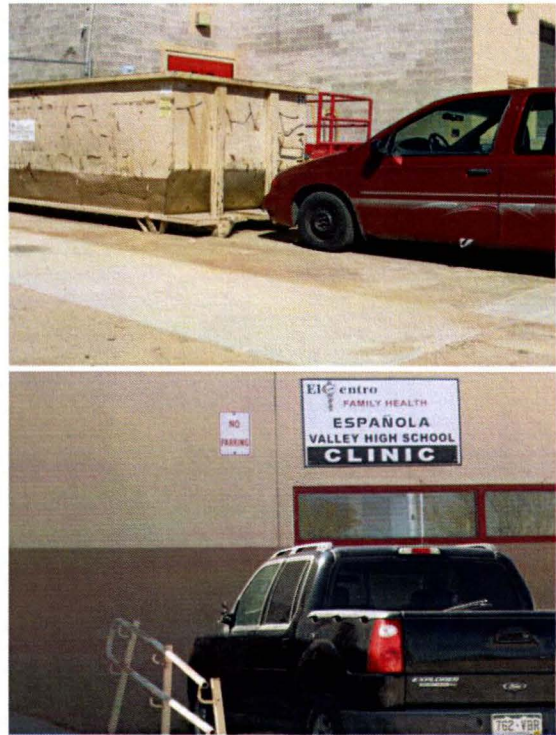
**Recommendation Number: 2014-001**

- Vehicles were parked on site in areas that are marked no parking or otherwise not designed for parking.
- This practice increases injury risk and the risk of property damage.

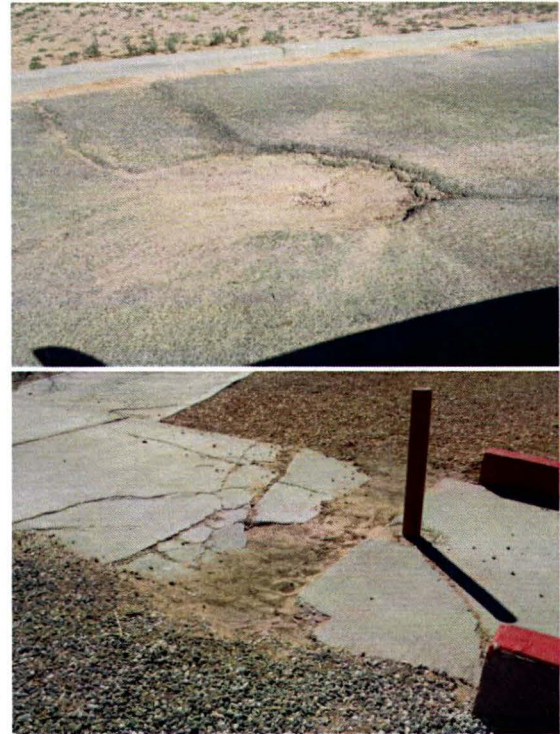
**Recommendation Number: 2014-002**

- Some of the paved areas had minor deterioration that, if left unrepaired, could worsen and result in trip/fall hazards.

- The pavement condition should be closely monitored and repairs made as needed.

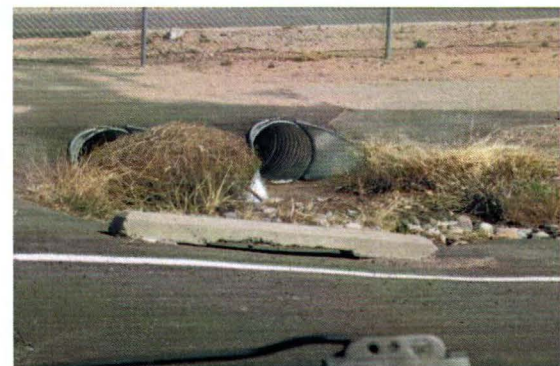
**Recommendation Number: 2014-003**

- Some of the culvert inlets were collecting trash and debris.
- This condition can lead to clogged culverts and flooding.

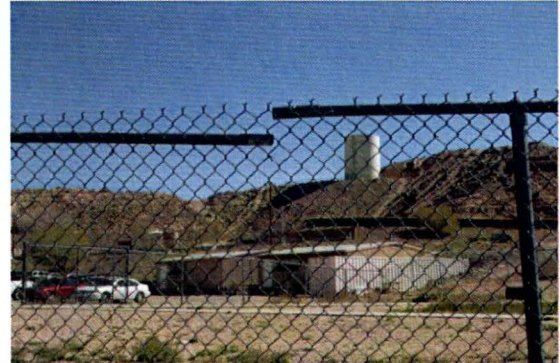
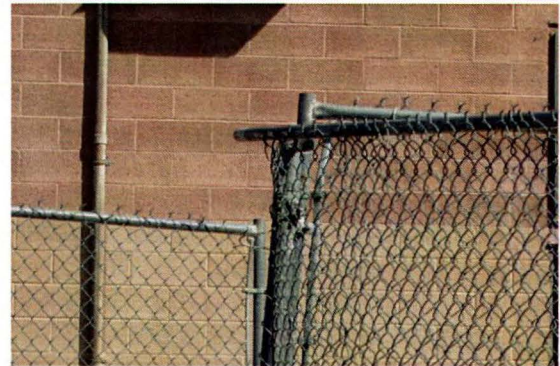
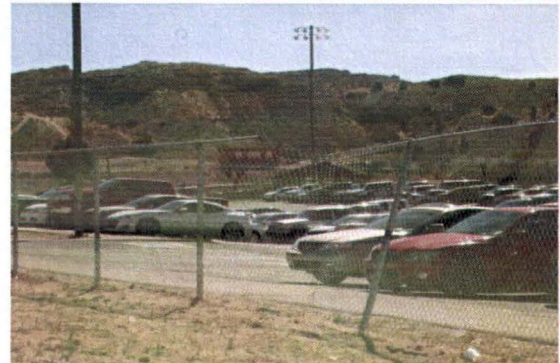
**4. Is fencing provided, and are fences and gates of an appropriate type and condition?****Recommendation Number: 2014-004****Observations:**

- Portions of the fence were damaged.
- The fence conditions pose attractive nuisance and injury hazards.

- Damaged fencing should be repaired.

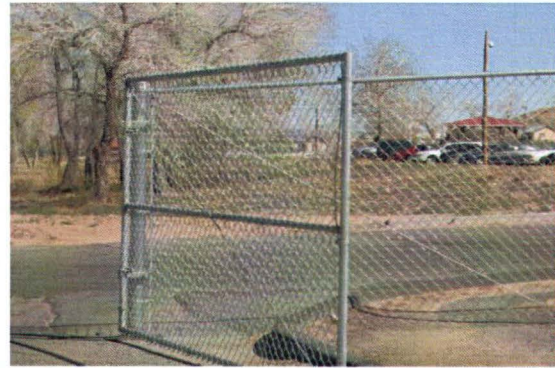
- The drive gates should be secured when open to prevent them from swinging closed on a vehicle in the wind.

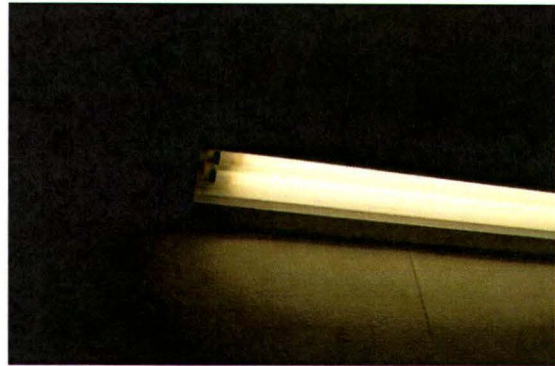
- Some of the light fixtures were missing diffusers.
- Light diffusers reduce glare, protect the light bulbs from damage, and reduce the hazards created by broken glass should bulbs break.

- Missing light diffusers should be replaced.
- Specially designed plastic sleeves may be used in place of light diffusers for fluorescent light bulbs.

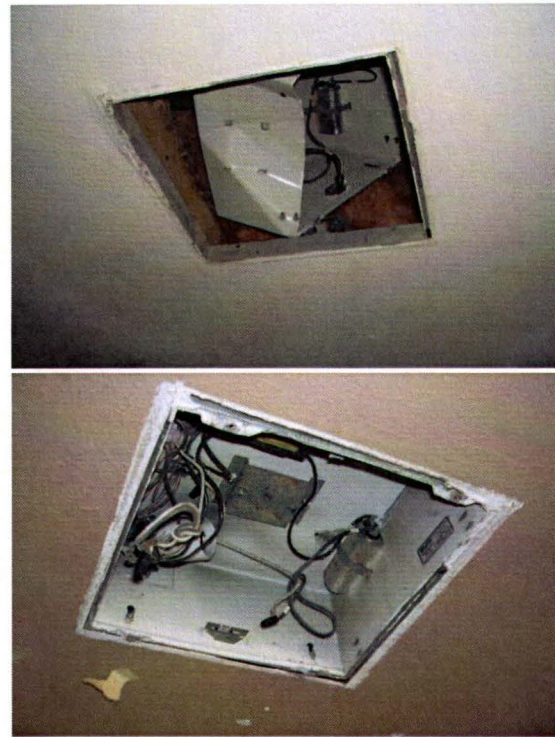
- One or more overhead lighting fixtures with exposed internal wiring were observed.
- The exposed wiring poses electric shock and fire hazards.

- If repair cannot be completed or is interrupted, electric component faceplates should be replaced to prevent accidental or unauthorized contact with electric wires.
- In addition, the energy sources should be locked and tagged out at the circuit breakers or disconnect boxes.

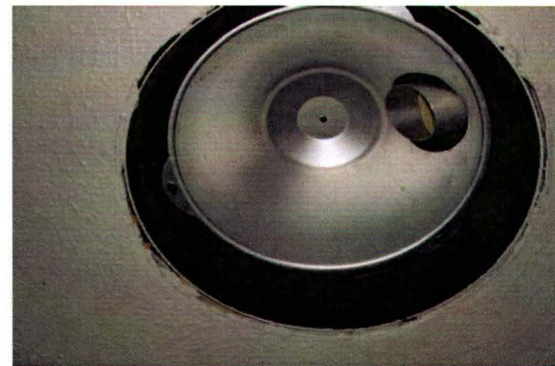
- Exposed light sockets were present where light bulbs were missing.
- The exposed light sockets increase the risks of electric shock and fire incidents.

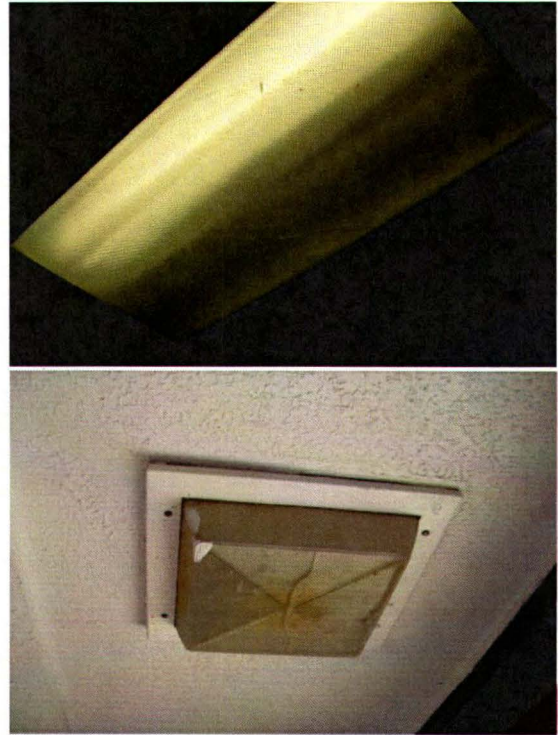
- Some of the light diffusers were broken or damaged.
- Light diffusers reduce glare and protect the light bulbs from mechanical damage and breakage.

- Damaged or broken light diffusers should be replaced.

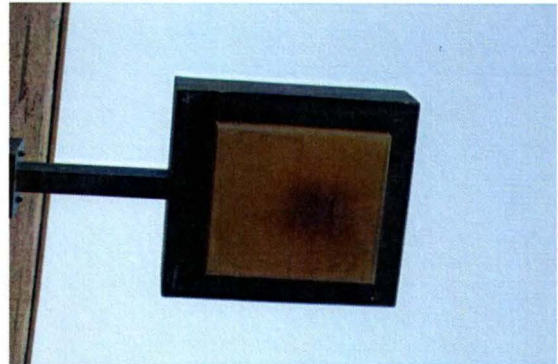
- An accumulation of dirt was visible in the diffusers for some of the overhead lights.
- Some of the light diffusers appeared to be yellowed.

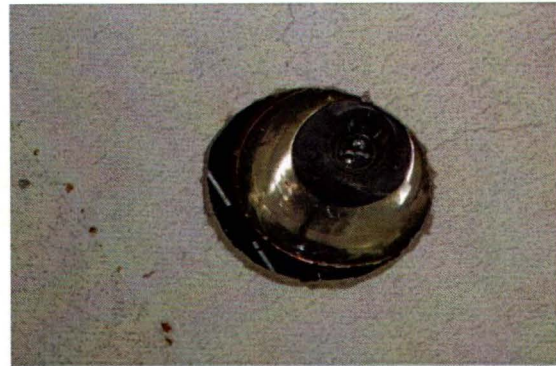
- Some light bulbs were broken and the bulb base still remained in the socket.

- The electric circuit on which the light fixture is located should be properly de-energized, and the light bulb base be removed.
- The broken light bulb should be replaced.
- Fixture covers should be installed to protect bulbs.

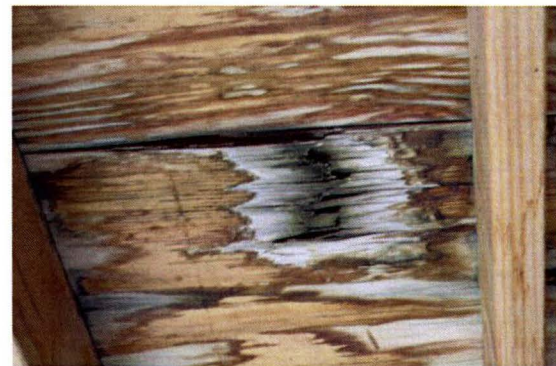
- The wooden trim and/or other wooden building components were deteriorated and/or dry-rotted in some places.

- The wooden building materials and the trim should be thoroughly examined to determine the extent of the damage and to determine the necessary corrective action.
- The deteriorated wooden components should be repaired and/or replaced.

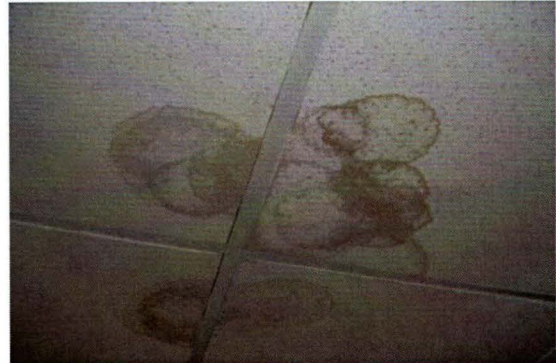
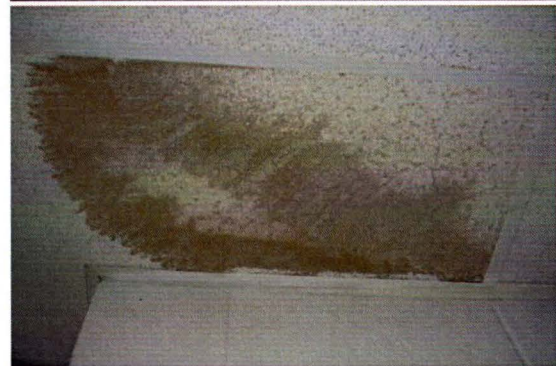
- Evidence of leaks and/or other water intrusion was present.
- Water intrusion and the presence of moisture in building materials can foster the growth of mold and mildew.

- The source of the water intrusion should be determined and corrective action taken to prevent recurrence.
- Wall coverings, ceiling tiles, floor coverings, and wall and ceiling insulation should be inspected to identify the presence of damage or mold growth. Both exposed and concealed surfaces should be inspected.
- Damaged and contaminated materials should be removed and disposed of in a way that prevents their continued use.
- The entire damaged or contaminated area should be cleaned and disinfected with an effective fungicide prior to installing new materials.

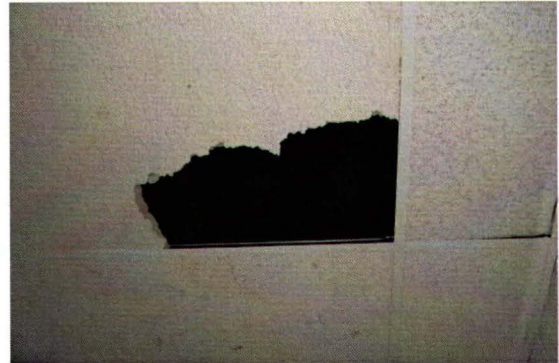
- Holes were observed in some of the ceilings.
- The holes compromise the fire safety of the structure, and they provide an entry point for insects and vermin.

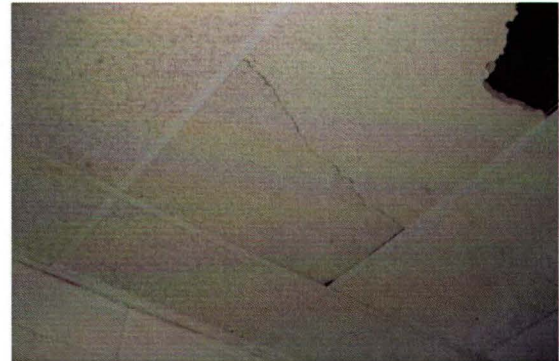
- Damaged suspended ceiling tiles were observed.
- These conditions pose falling object hazards that could result in personal injury.

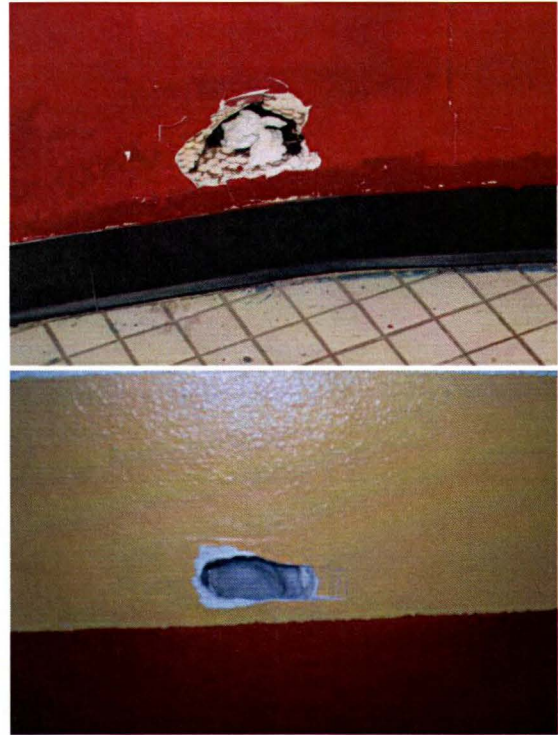
- The wall covering observed in one or more areas was damaged and/or peeling.
- The damaged areas pose an attractive nuisance and invite more damage.

- Any damage to the walls or wall coverings should be repaired.

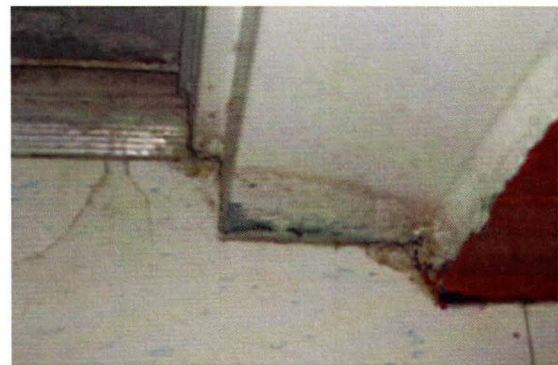
- Some of the baseboard molding observed was missing.

- The missing molding should be securely replaced.

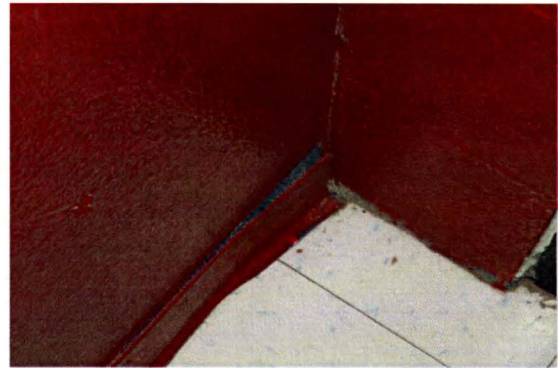
- Some of the baseboard molding observed was loose.
- This condition poses trip/fall hazards.

- The loose molding should be securely fastened to the wall.

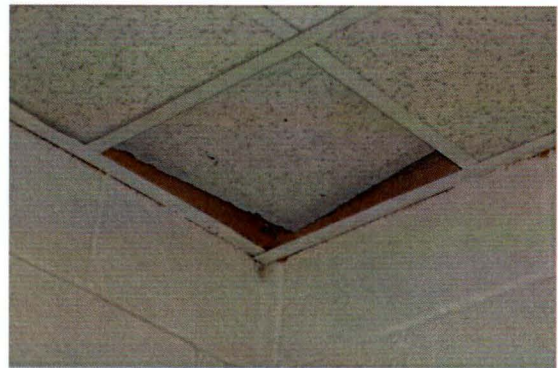
- Loose suspended ceiling tiles were observed.
- These conditions pose falling object hazards that could result in personal injury.

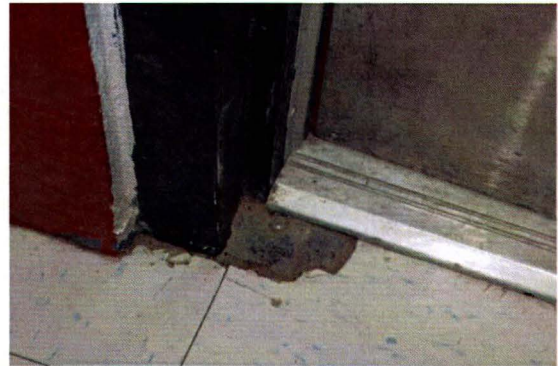
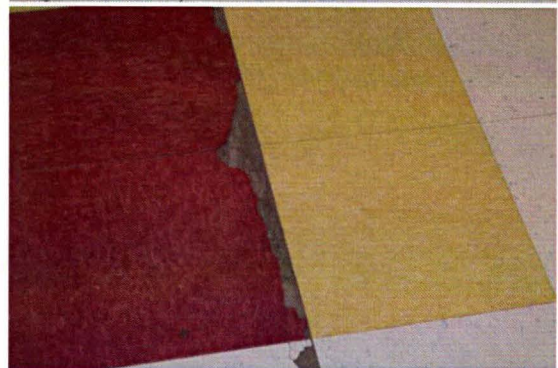
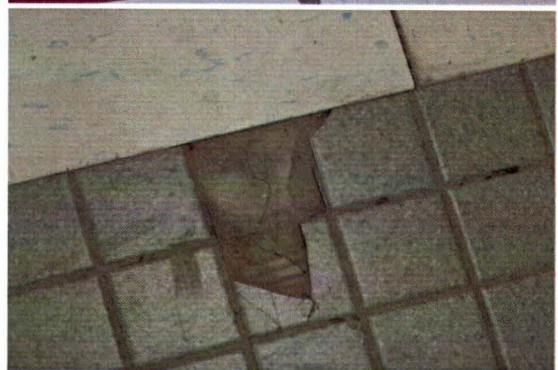
- Some of the floor tiles were damaged.
- The damaged flooring presents slip/trip/fall hazards.
- Some of the damaged floor tiles or their adhesive may contain asbestos, which could present an asbestos exposure hazard.

- The site Asbestos Management Plan should be reviewed to determine if the flooring contains asbestos.
- Damaged flooring that does not contain asbestos should be removed and replaced.
- Damaged flooring that contains asbestos should be abated in accordance with AHERA requirements.
- Missing and damaged floor tiles should be repaired and/or replaced to reduce trip/fall hazards.

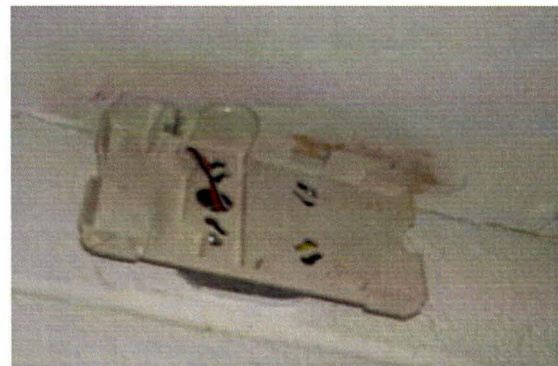
- Some exit signs were damaged and/or broken.

- Damaged exit signs should be repaired.
- Exit signs should be provided with bulbs for all sockets, so that the signs are still illuminated even if one bulb fails.
- Illuminated exit signs should be installed above exits to ensure that exit routes are properly identified.
- Illuminated exit signs should be properly installed.

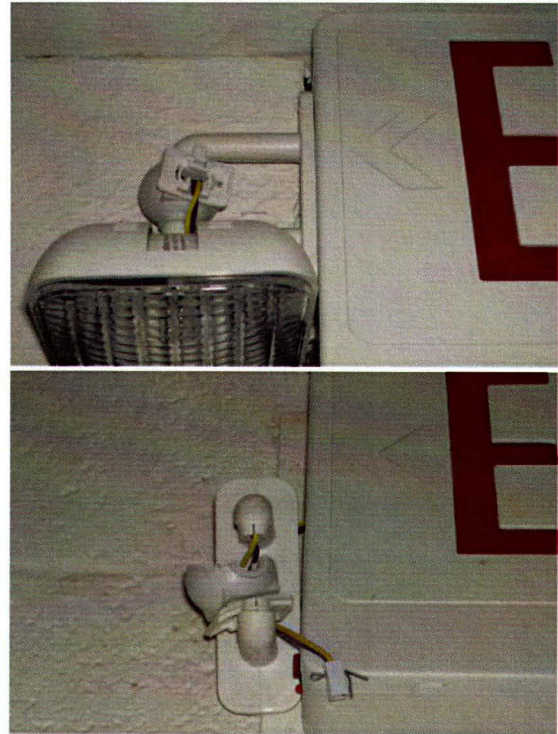
- Exit signs and/or emergency lights were damaged.

- Damaged exit signs and/or emergency lights should be repaired.
- Consideration should be given to installing approved protective metal grills over illuminated exit signs and emergency light installations that may be at risk of damage due to their location and/or the activity conducted in the room, as in gymnasium and athletic activity rooms.

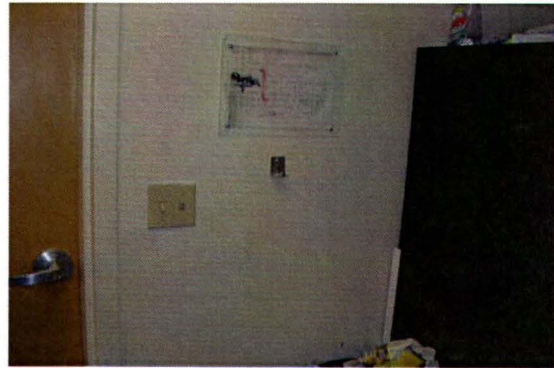
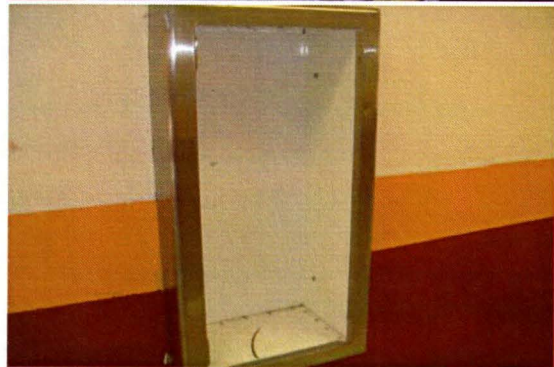
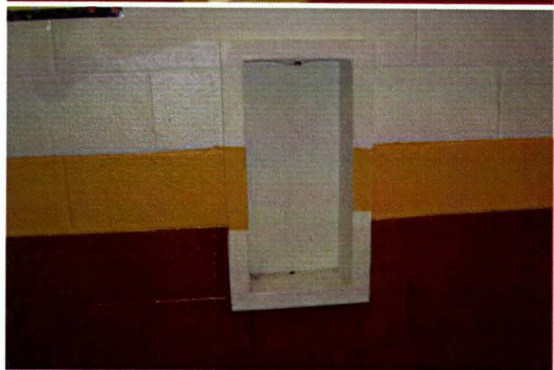
**Recommendation Number: 2014-024**

- Fire extinguishers were missing from some areas.

- Missing fire extinguishers should be replaced and properly wall mounted.
- Consideration should be given to indicating fire extinguisher locations on site emergency evacuation maps to ensure that fire extinguishers are properly replaced following service.

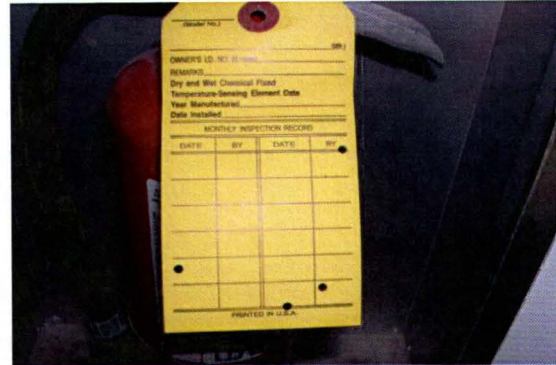
- Monthly fire extinguisher inspections are not being conducted.

- The fire extinguishers should be inspected on a monthly basis to ensure that:
  - they are properly wall mounted;
  - the seals and pull pins are still intact; and
  - the units are fully charged and ready for use.
- The monthly inspection should be documented with the inspector's initials on the back of the annual inspection tag.

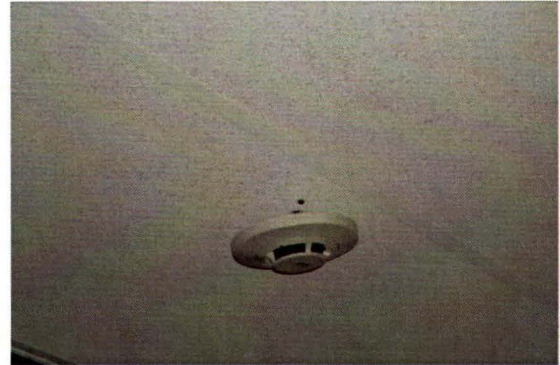
**Recommendation Number: 2014-027**

- Smoke/heat detectors coming loose from the ceiling.

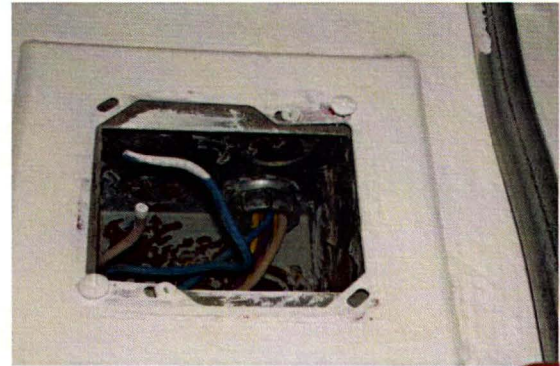
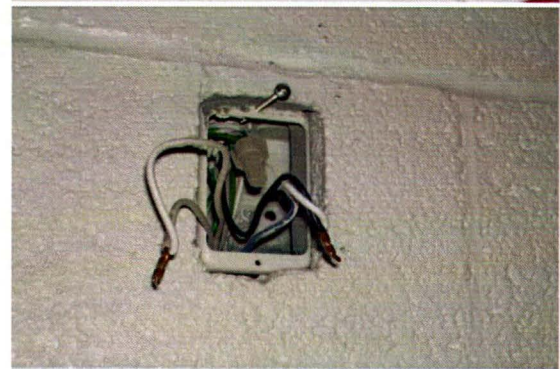
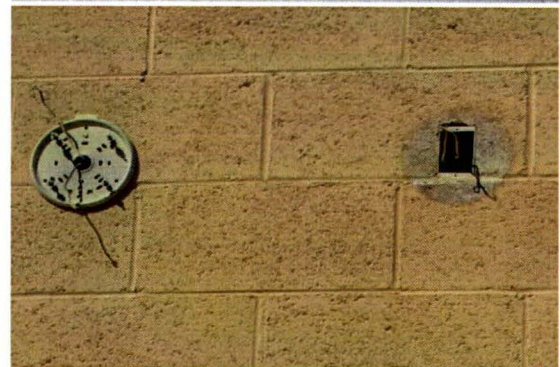
**Recommendation Number: 2014-029**

- Some of the electrical wiring was exposed.
- Exposed wiring poses an electric shock hazard.

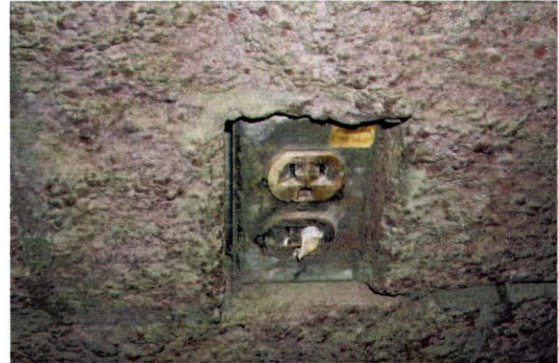
- Some electric receptacles were scorched. These receptacles may be damaged and/or defective.
- The use of damaged receptacles increases the risk of injury and fire incidents.

- The scorched receptacles should be inspected and replaced if necessary. The circuit should be de-energized and locked-out until repairs are made.

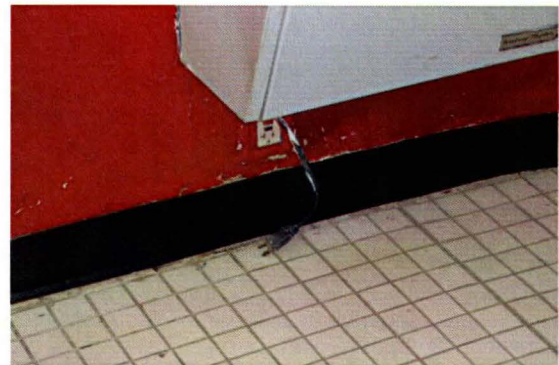
- One or more of the drinking fountains were found to be unplugged.

- Drinking fountains should be powered to operate according to manufacturer's specifications.

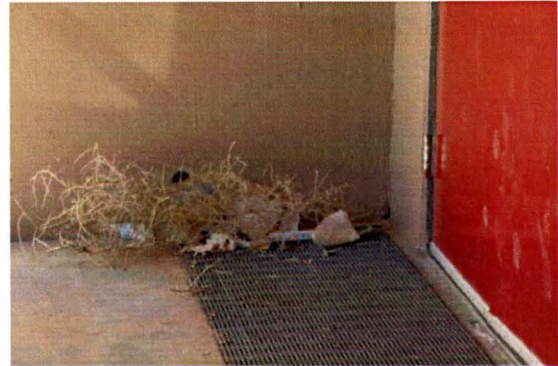
**Recommendation Number: 2014-032**

- Accumulated weed debris and trash was present on sidewalks and/or in parking lots areas. This condition poses slip/fall hazards.
- Dry tree debris may present a fire hazard.
- Accumulated debris may also clog storm drains and/or gutters, which could lead to flooding or the improper drainage of water.

- The accumulation of weed debris and trash should not be permitted on walkways, roadways, and/or parking lots.

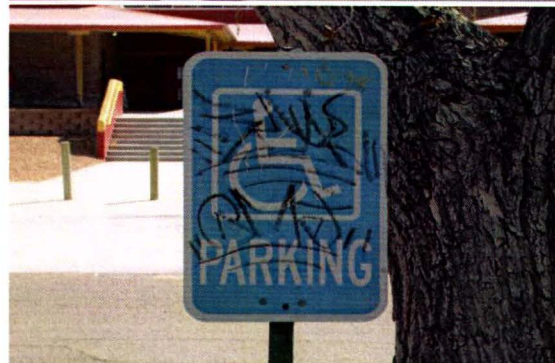
**Recommendation Number: 2014-035****Observations:**

- Evidence of vandalism was observed.
- The damaged property posed injury hazards, and encouraged additional acts of vandalism.

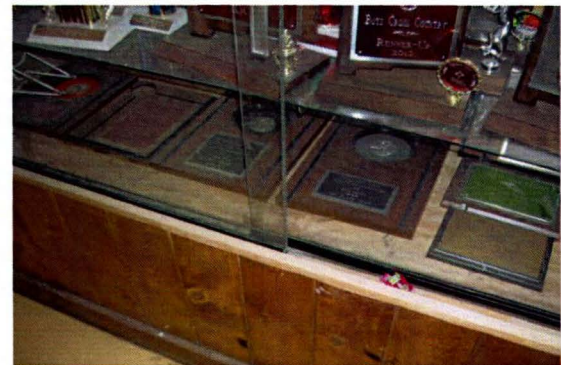
- Some of the trophy cases were found to be open and unsecure.
- This could lead to theft and vandalism.

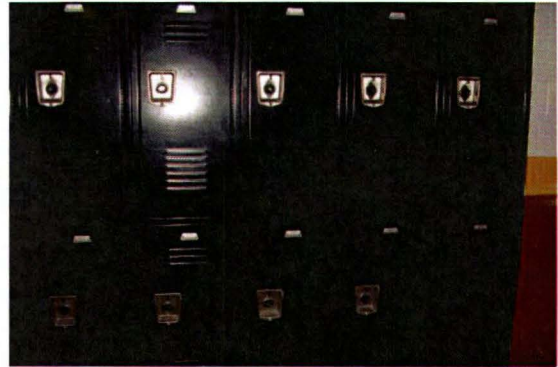
- Student lockers were present but not in use. Eliminating student lockers may reduce vandalism, contraband, and harassment incidents.

- Consideration should be given to removing the lockers.
- If the District chooses to retain the lockers, any damaged lockers should be repaired or replaced.
- If lockers are retained and used, they should be assigned by grade level to reduce the likelihood of harassment between grade levels.

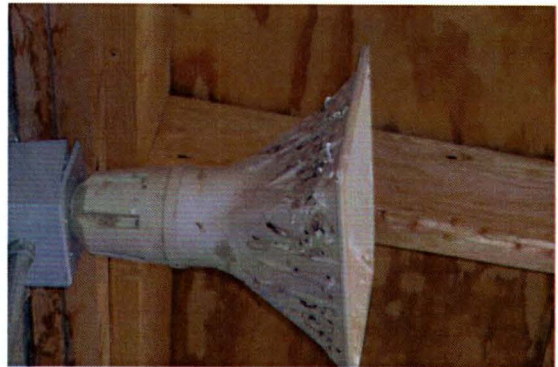
- Bird nests were observed in the exterior lights, building structures, and/or exterior utility structures.
- The bird nests can pose fire, health, and property damage hazards.

- Bird nests, bird droppings, and any other debris should be removed.
- Bird droppings should be cleaned using the appropriate personal protective equipment and disposed of as potentially infectious material.
- Holes and/or openings in which birds roost should be treated or sealed off to prevent the birds from nesting.

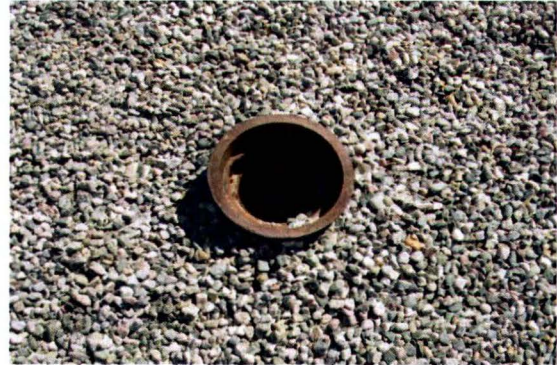
- Some of the ground level utility covers were missing.
- The open utility vaults pose trip/fall hazards.

- Missing utility covers should be replaced and kept in place at all times.

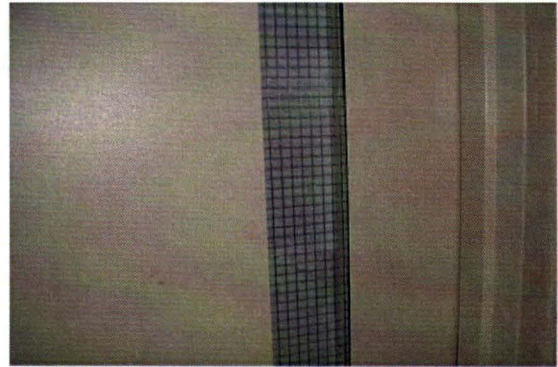
**Recommendation Number: 2014-040**

- Paper was observed over the windows of the classroom doors.
- This practice compromises the security of the room's occupants and violates the requirement to keep doors free of decorations.
